# Installation & Service Bulletin

## Velvet Drive®

MB51

### SUBJECT: Breather Leaks

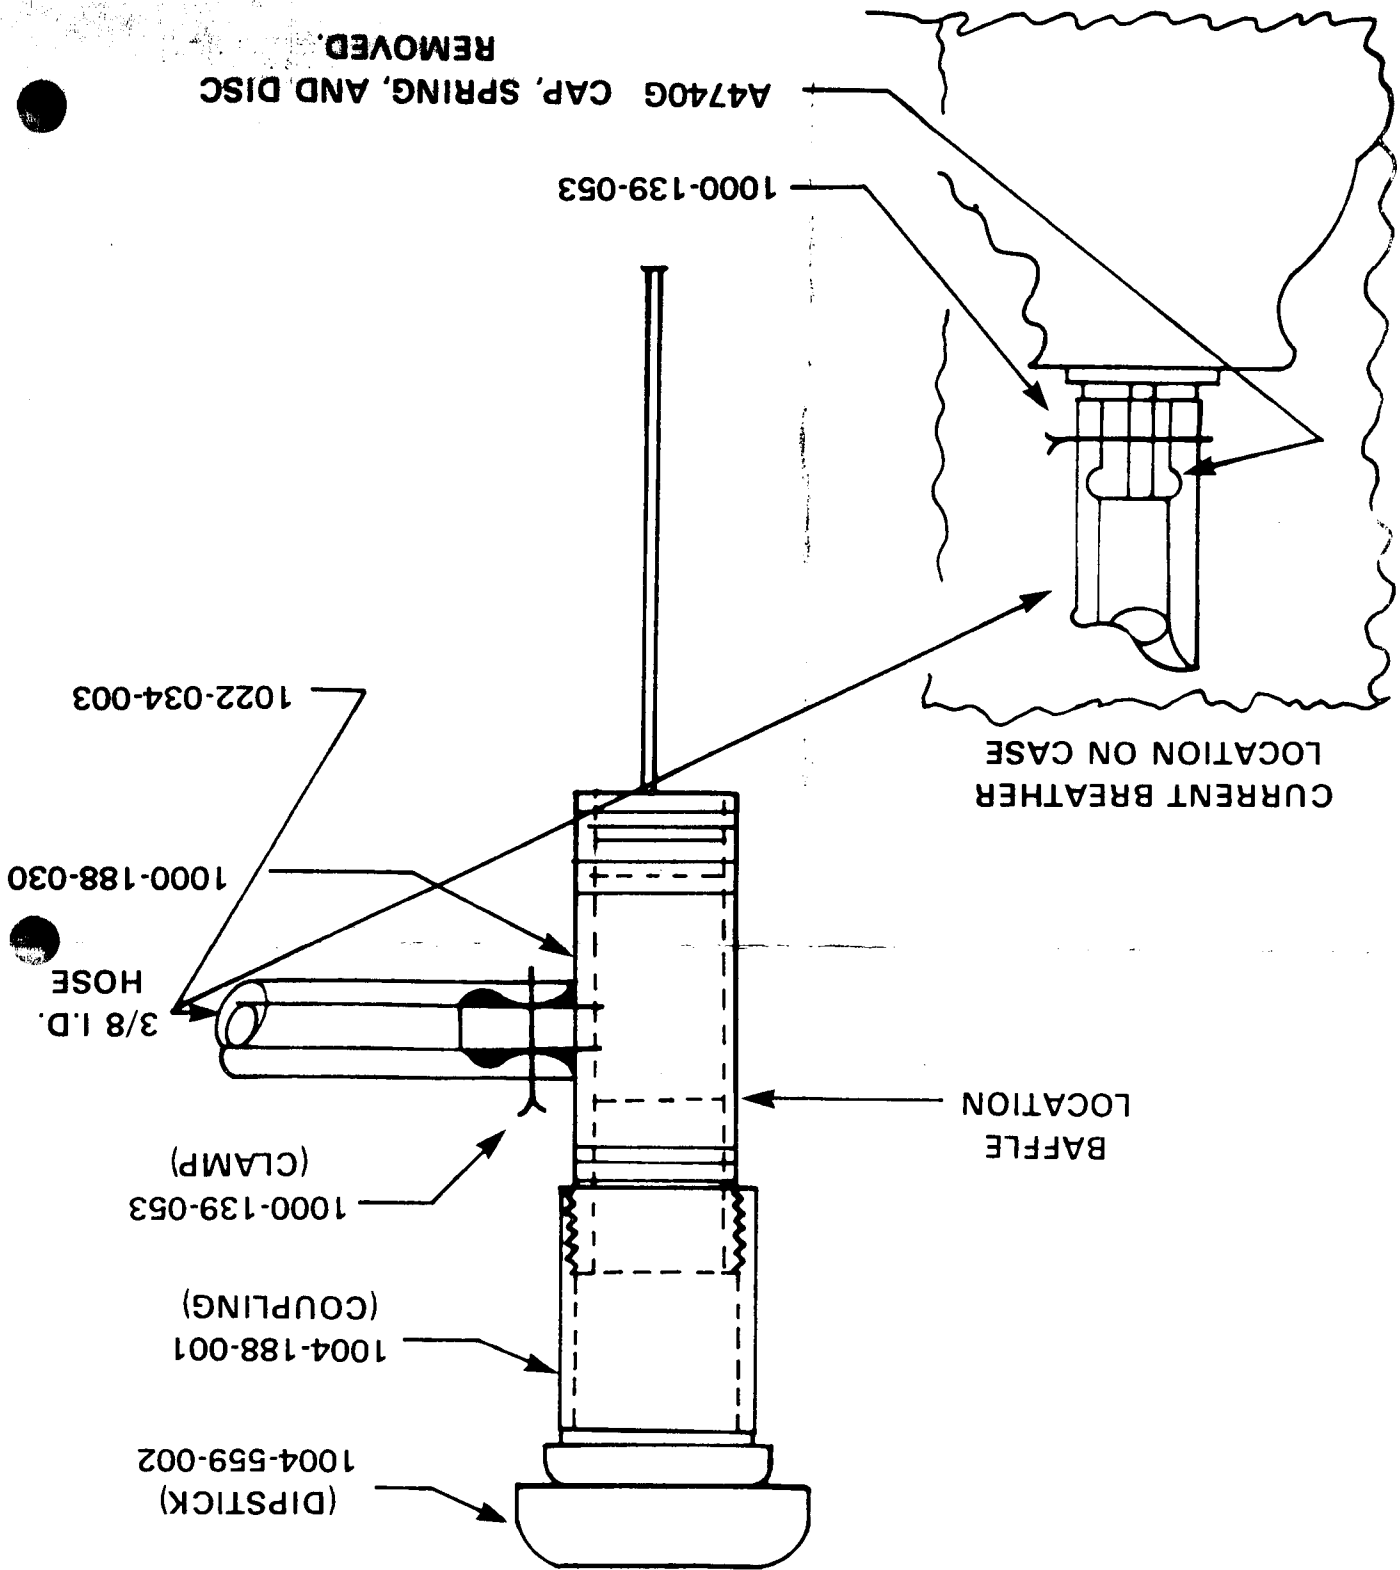
MARINE BREATHER LEAK FIX

DIPSTICK & TUBE SUBASSEMBLY

KIT PART #1017-410-001

The following procedure is used to install the kit. Check and adjust the oil level to the full mark on the dipstick. The original dipstick and filler tube must be removed to install the new components. Remove the breather cap, spring, and disc from breather body. Screw the new pipe nipple and coupling into the threaded fill tube opening of the case. Assemble hose clamps over end of the hose as the hose is connected to the body of the breather and to the hose fitting in the pipe nipple. See illustration. Use a chisel or small file to make a full oil level mark on the new dipstick.
